Coastal Habitat Restoration in New Hampshire

Ted Diers and
Jen Drociak
NH Coastal Program

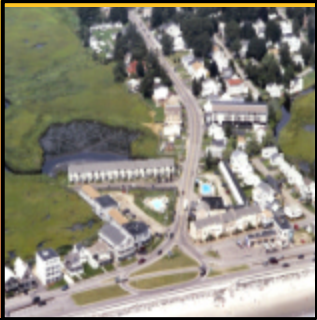
Example:
Tidal Restrictions

Hampton Marshes, Hampton

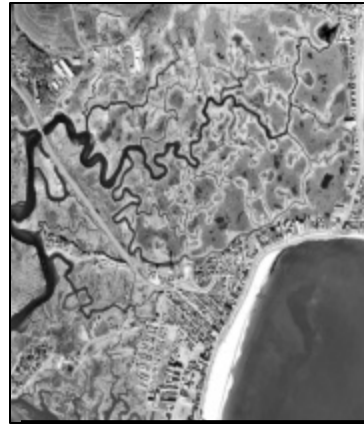
Ditching & Draining

Hampton Marshes, Hampton

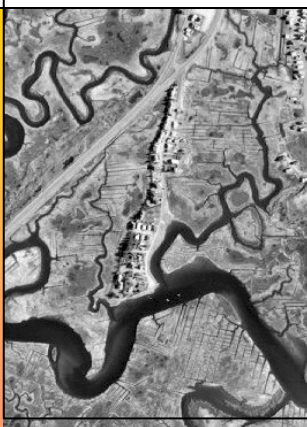
Fill on the Marsh

Awcomin Marsh, Rye

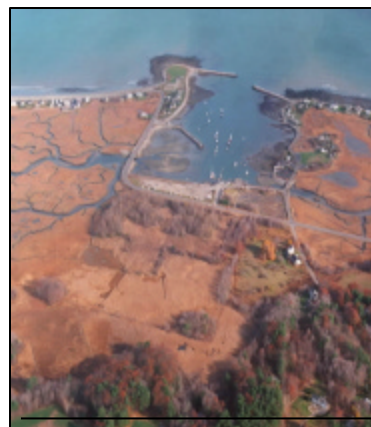
Stormwater Inflow

Parson's Creek, Rye

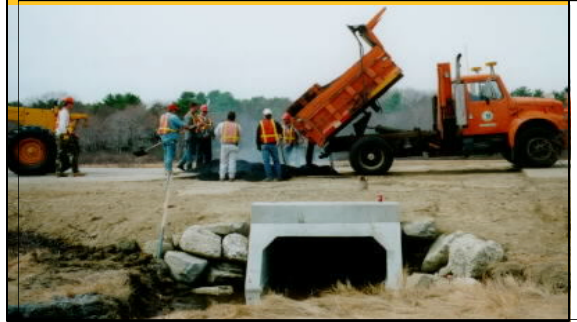
Removal of Tidal Restrictions

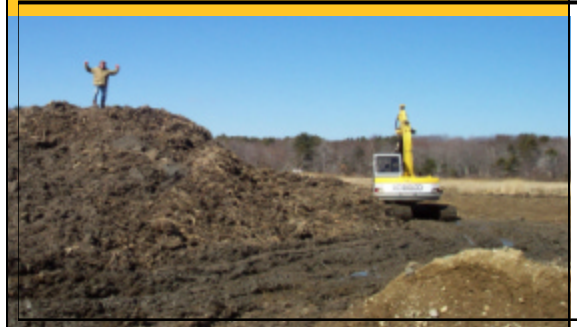
Removal of Fill

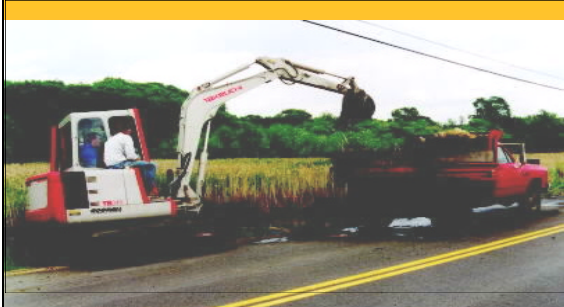
Perimeter Ditches to Remove Stormwater

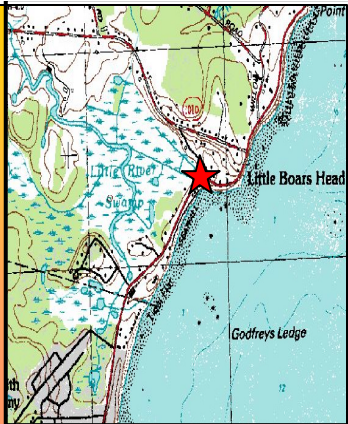
The Issue: Tidal Restriction (48" Culvert) Under Rt 1A.

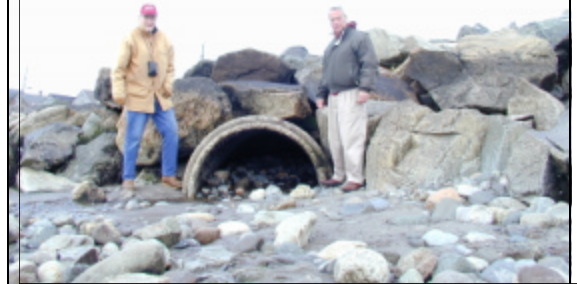
The “Clogged Bathtub”

Little River Marsh Tides -- 10/17/97

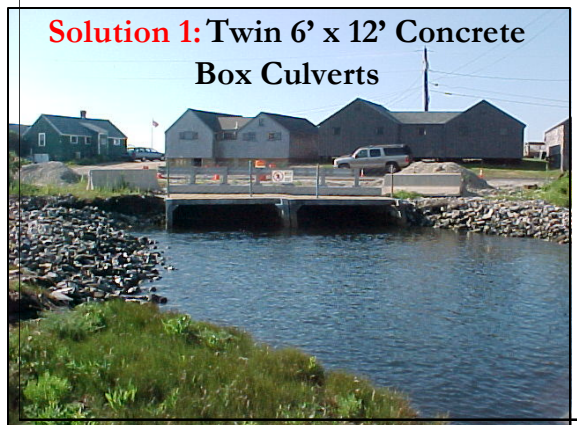
Culvert Installation

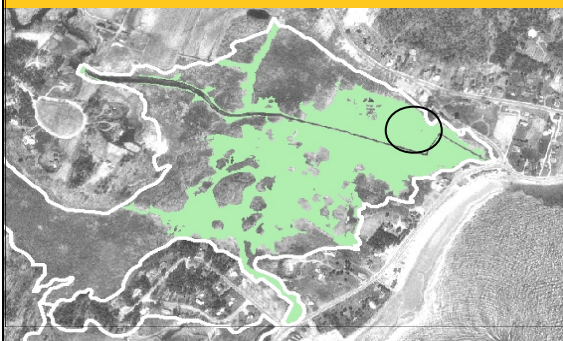
Loss of Healthy Vegetation

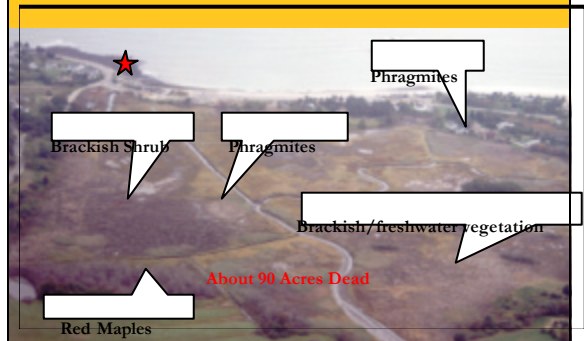
The “Dead Zone”

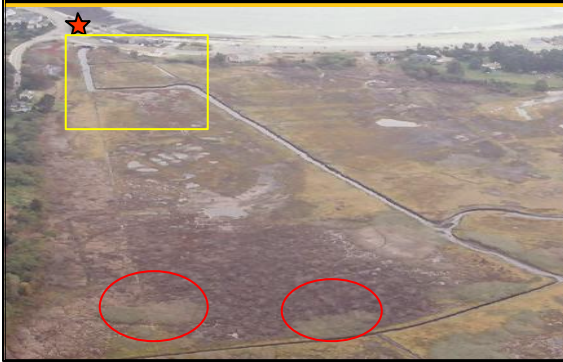
Expansion of Phragmites?

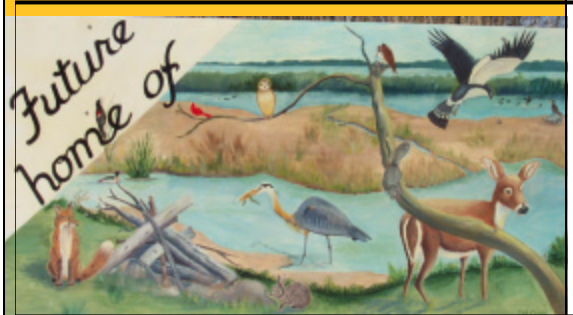
The Issue: Historic Dredge Spoils on Marsh from Rye Harbor

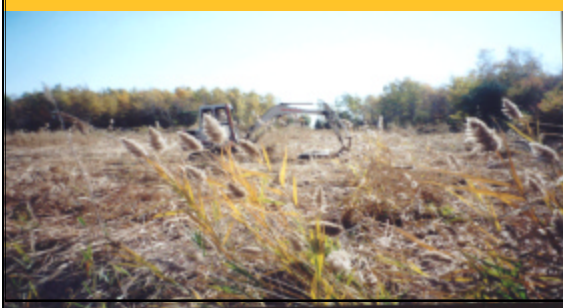
Solution 1: Cut Phragmites & Determine “What Lies Beneath”

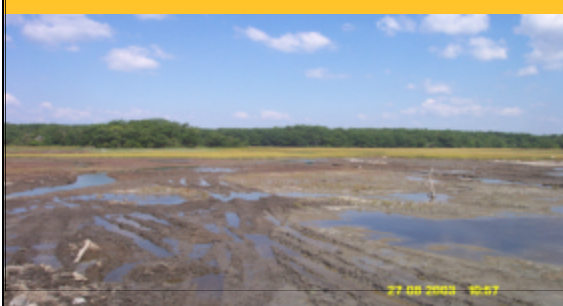
Solution 2: Remove Fill & Restore Proper Elevations

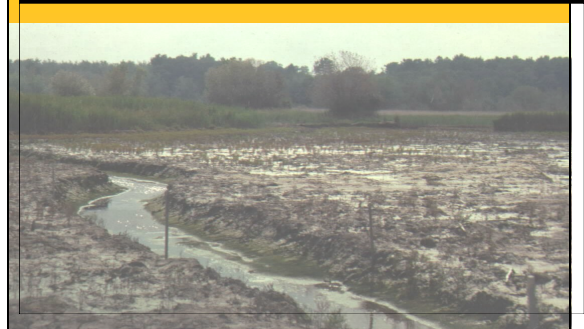
Solution 3: New Tidal Channels

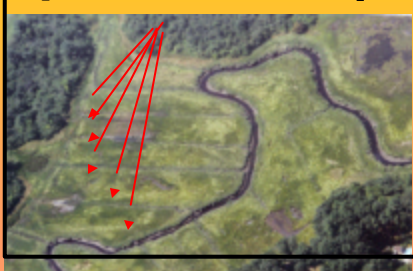
The Issue:

Ditching + Loss of
Open Water Habitat = Mosquitoes

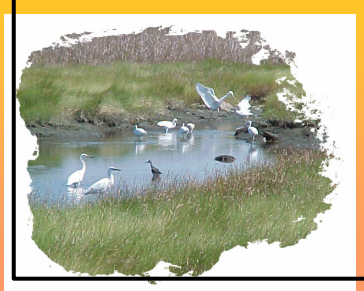
The Solution: Ditch Plugging & Creation of Pools
